26 March 2008

## Tree Report to New Park Centre, Chichester

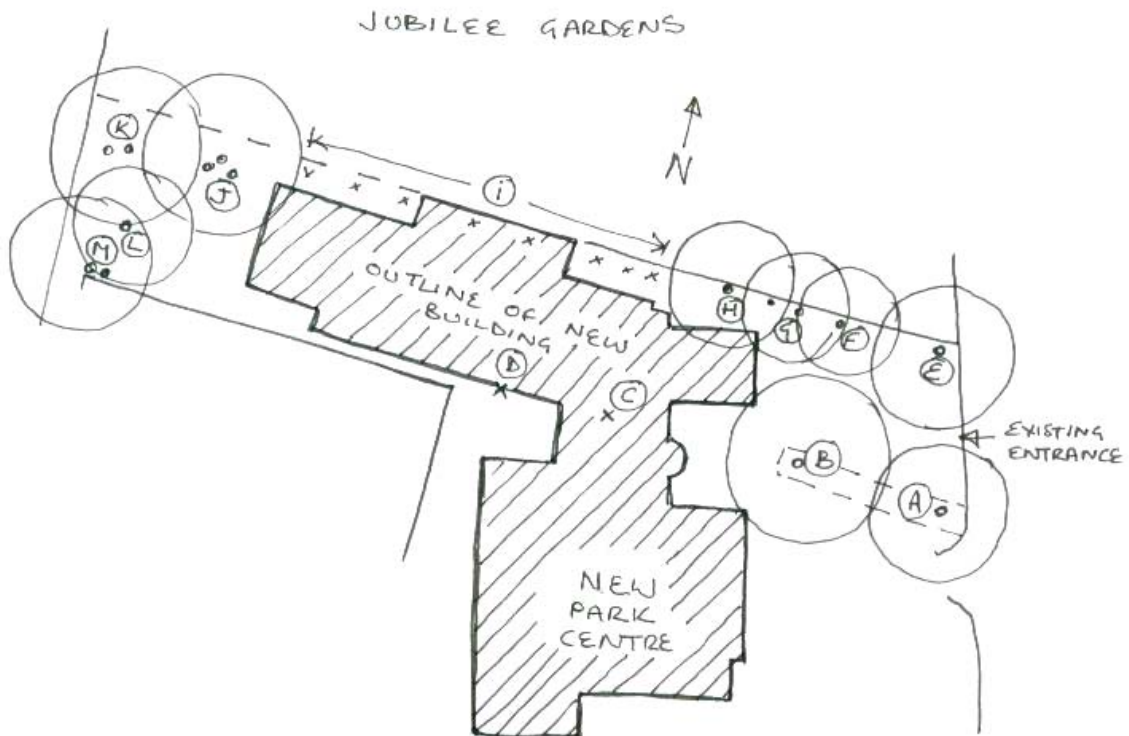
Trees as marked and lettered on the above drawing:

A-E Tilia x europaea – common lime

F-M Acer pseudoplatinus – sycamore

Trees C, D and I group (about eight sycamores are shown as removed on the architectural drawings. Whilst C & D are mature limes, their removal is unavoidable for this scheme. Some of the Sycamores could possibly remain but as they are not trees of any outstanding merit, their loss will not be of significance and they would be within three metres of the new building.

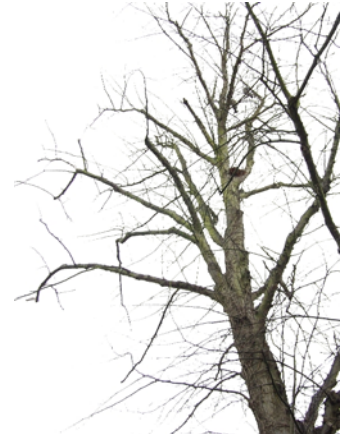
- A. Tilia x europaea – common lime  
Height: 19.8 m DBH (dia. breast height): 800mm  
Spread: 5m (radius):7 m  
Condition: tree has some branches exhibiting advanced die-back overhanging the road and pavement, and these should be removed. Crown seems to be in good condition. A large amount of suckering has occurred at the base, as is usual for limes.  
Recommendations: removal of all dead wood, further (climbing) inspection

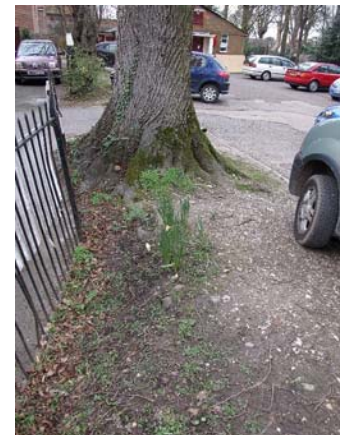
- B. Tilia x europaea – common lime  
Height: 20.6 m DBH:1000mm Spread: 9 m  
Condition: in good general condition, this is the most visually important tree on the site and whilst marked for retention it is in the most danger from the redevelopment. This is because of the raised roots that run along the earth strip between it and tree A, some 3-400mm above the surrounding ground level. These are major roots, providing structural support and cannot be removed, meaning the entrance and parking layout as proposed may have to be re-designed.

Recommendations: General deadwooding, removal of branch stubs and further visual inspection by climbing. Protection of roots as described otherwise removal may cause windblow.

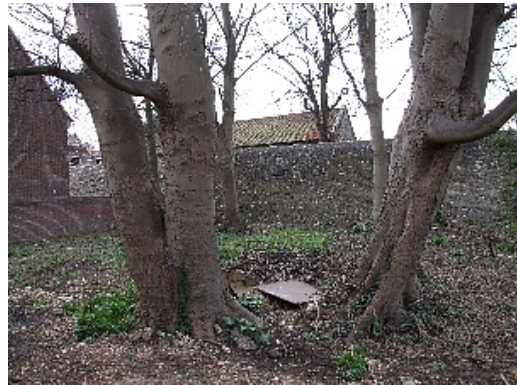
Condition: Generally good, an established clump of sycamores, in three main groups with twin or triple trunks. These are removed from the immediate area of development and so should be unaffected.

Recommendations: No storage or plant should be allowed to the entire area, which should be fenced off entirely with access forbidden. General deadwooding and removal of stubs, with further climbing inspection.
